Understanding Columbia's Reentry Problems

Thomas Paul. Lockheed Martin Space Operations, Houston, TX

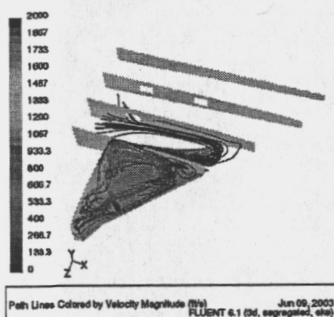
shuttle-path.tif: Pathlines inside the wing cavity, showing impingement on the wheel well wall at left by the jet entering through a breach in the wing

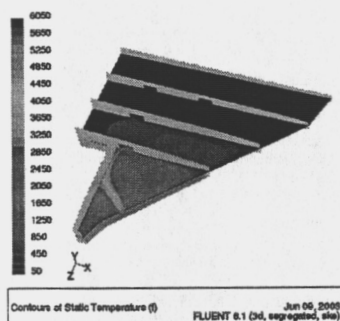
shuttle-temp.tif: Temperature contours show the heating caused on the wheel well wall by the hot, high speed jet entering through the wing breach

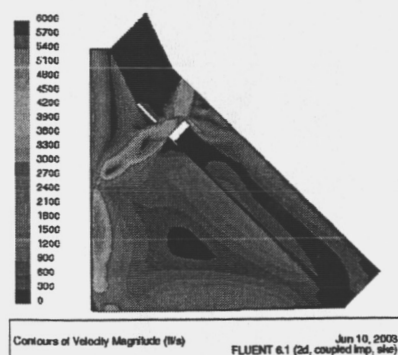
shuttle-2d-vel.tif: 2D simulation showing the path of the jet entering through the RCC breach on the outside of the vehicle, then through the spar breach, and into the wing cavity, ultimately hitting the wheel well wall
